**Flood Control Project Maintenance  
Levee Inspections**

**Fall 2011 Levee Maintenance Deficiency Summary Report**

**Sacramento River Basin**

**Reclamation District No. 0537 Lovdal**

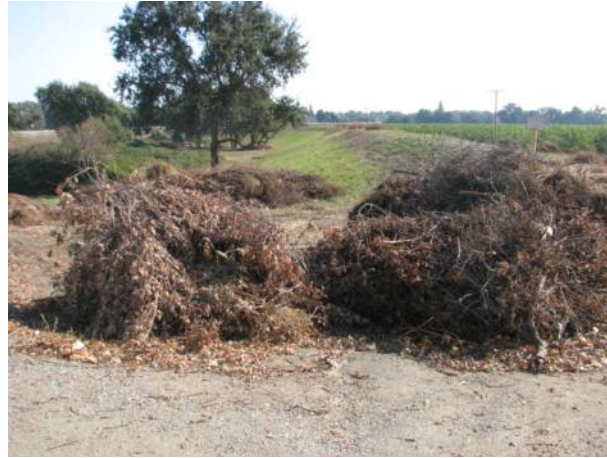
Levee Mile Report Line	3
Start Levee Mile	0.56
End Levee Mile	0.56
Location	Land Side
Category	Earthen Levee
Item	Encroachments

Piles of brush on the levee crown at the setback levee. Fall 2011

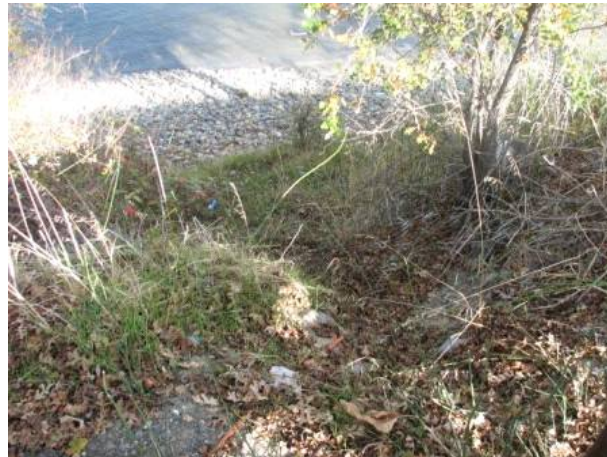
Levee Mile Report Line	4
Start Levee Mile	0.72
End Levee Mile	0.72
Location	Water Side
Category	Earthen Levee
Item	Erosion / Bank Caving

This is a photo of the eroison and the bank.

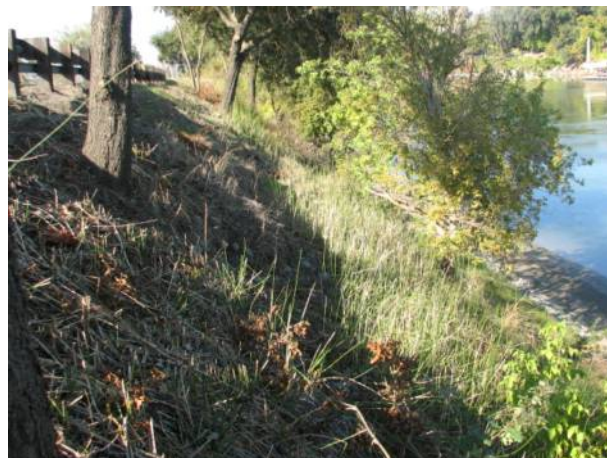
Levee Mile Report Line	4
Start Levee Mile	0.72
End Levee Mile	0.72
Location	Water Side
Category	Earthen Levee
Item	Erosion / Bank Caving

The slope is eroison site is at Monument Bend. Fall 2011

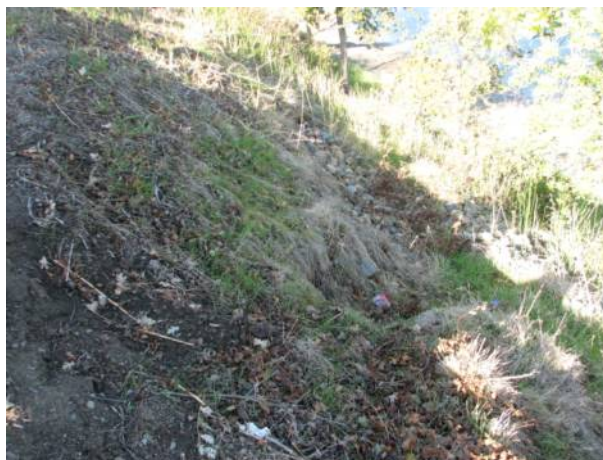
Levee Mile Report Line	4
Start Levee Mile	0.72
End Levee Mile	0.72
Location	Water Side
Category	Earthen Levee
Item	Erosion / Bank Caving

Another view of some badly eroded areas. Fall 2011

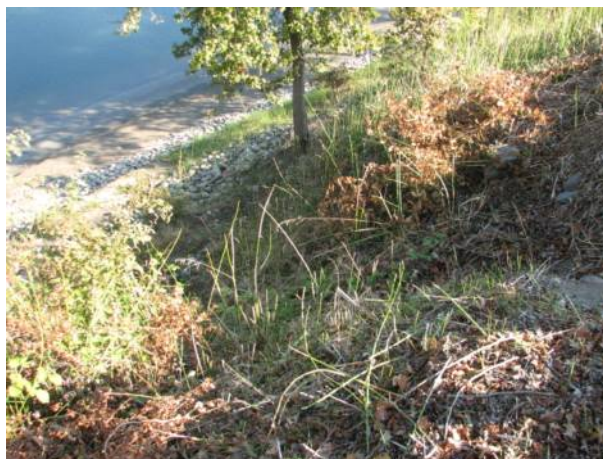
Levee Mile Report Line	4
Start Levee Mile	0.72
End Levee Mile	0.72
Location	Water Side
Category	Earthen Levee
Item	Erosion / Bank Caving

Another view of the site. Fall 2011

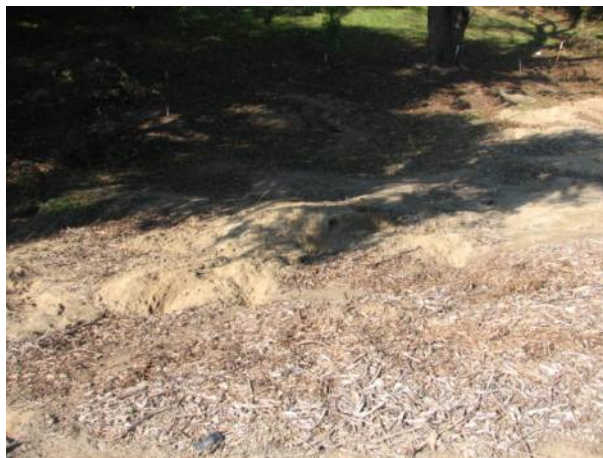
Levee Mile Report Line	5
Start Levee Mile	1.93
End Levee Mile	1.93
Location	Land Side
Category	Earthen Levee
Item	Animal Control

Rodents holes with a large volume of soil removed. Fall 2011

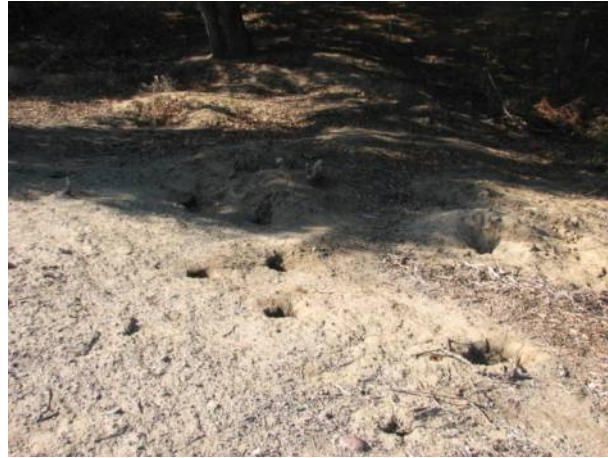
Levee Mile Report Line	5
Start Levee Mile	1.93
End Levee Mile	1.93
Location	Land Side
Category	Earthen Levee
Item	Animal Control
There are multiple holes in the same area. Fall 2011	
johngw_f_20111108_527.jpg

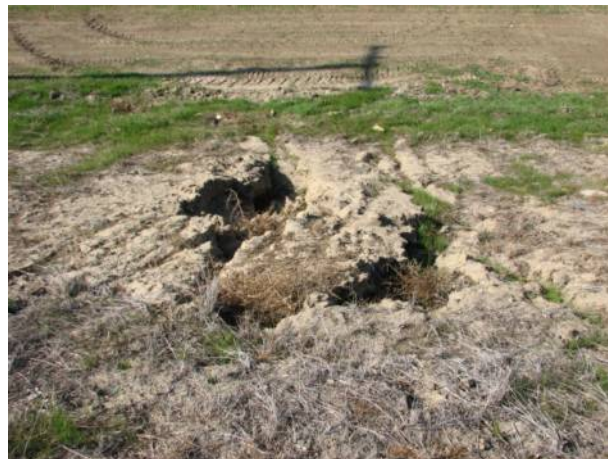
Levee Mile Report Line	6
Start Levee Mile	2.36
End Levee Mile	2.36
Location	Land Side
Category	Earthen Levee
Item	Erosion / Bank Caving
Bank eroison possible caused by rodent holes. Fall 2011	
johngw_f_20111108_528.jpg

6	2.36	2.36	Earthen Levee	Erosion / Bank Caving	LS	M	Schedule repair of erosion site prior to the next inspection.	38.627124 ° -121.563842 °	38.627124 ° -121.563842 °	41 Y
7	2.36	2.36	Earthen Levee	Encroachments	WS	M	Tree or limb	38.627125 ° -121.563758 °	38.627125 ° -121.563758 °	38 Y
8	2.40	2.40	Earthen Levee	Animal Control	LS	M	Exterminate rodents and backfill and compact or grout burrows.	38.626438 ° -121.563794 °	38.626438 ° -121.563794 °	42 Y
9	2.58	2.64	Earthen Levee	Encroachments	LS	PO	Landscaping	38.623988 ° -121.563663 °	38.623067 ° -121.563580 °	1 Y
10	2.60	2.60	Earthen Levee	Animal Control	WS	M	Exterminate rodents and backfill and compact or grout burrows.	38.623609 ° -121.563471 °	38.623609 ° -121.563471 °	37 Y
11	2.71	2.71	Earthen Levee	Erosion / Bank Caving	LS	M	Schedule repair of erosion site prior to the next inspection.	38.622034 ° -121.563433 °	38.622034 ° -121.563433 °	43 Y

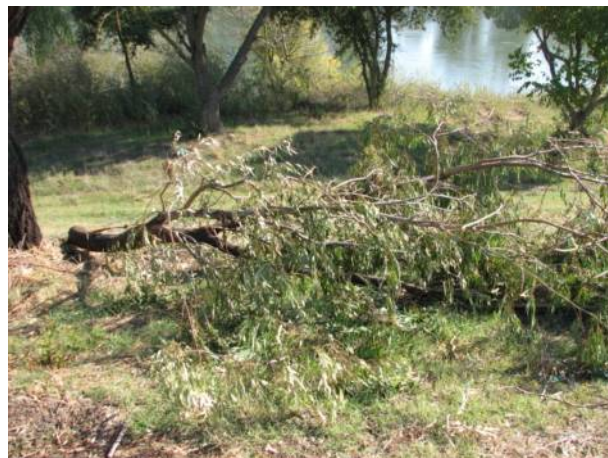
Levee Mile Report Line	7
Start Levee Mile	2.36
End Levee Mile	2.36
Location	Water Side
Category	Earthen Levee
Item	Encroachments
A tree limb has broken off and needs to be removed. Fall 2011	
johngw_f_20111108_529.jpg

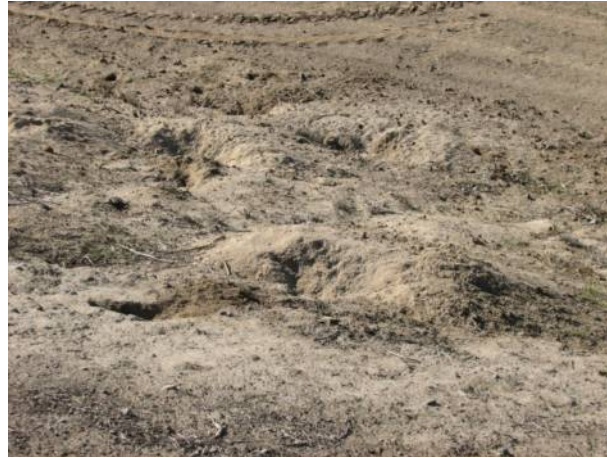
Levee Mile Report Line	8
Start Levee Mile	2.40
End Levee Mile	2.40
Location	Land Side
Category	Earthen Levee
Item	Animal Control

Rodent hole have a large volume of soil removed.  
Fall 2011

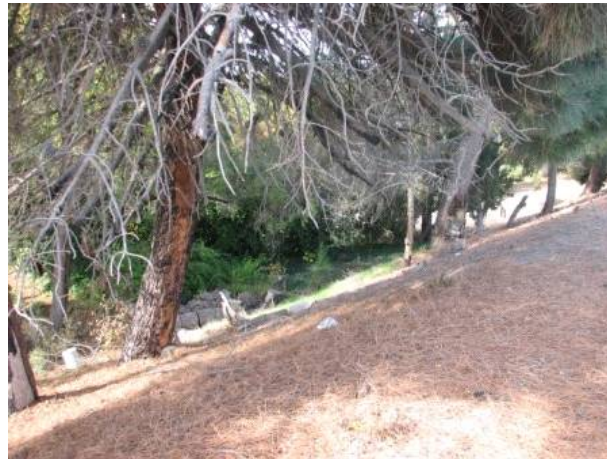
Levee Mile Report Line	9
Start Levee Mile	2.58
End Levee Mile	2.64
Location	Land Side
Category	Earthen Levee
Item	Encroachments

Landscape shrubs at the toe of the levee.

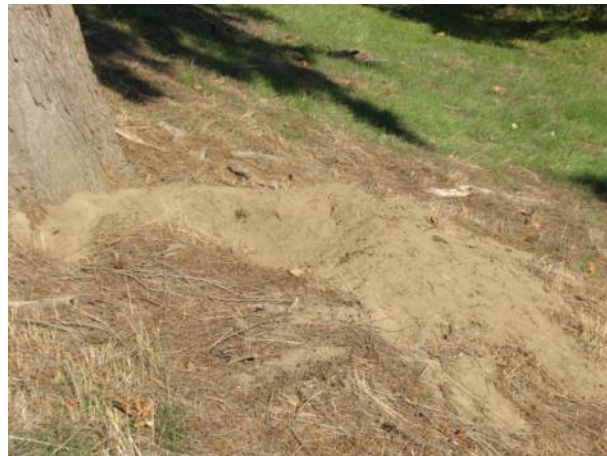
Levee Mile Report Line	10
Start Levee Mile	2.60
End Levee Mile	2.60
Location	Water Side
Category	Earthen Levee
Item	Animal Control

A large rodent hole at the base of the tree. Fall 2011

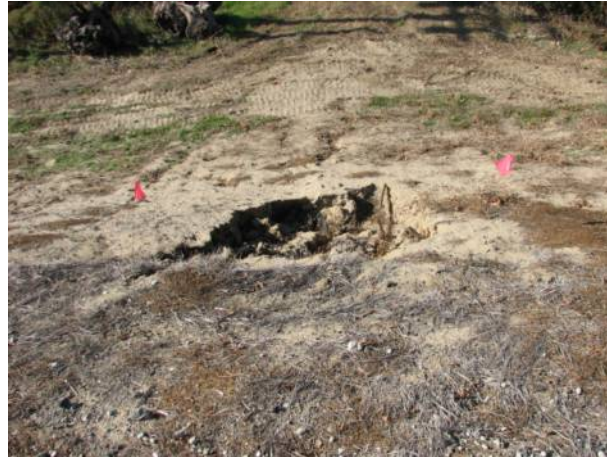
Levee Mile Report Line	11
Start Levee Mile	2.71
End Levee Mile	2.71
Location	Land Side
Category	Earthen Levee
Item	Erosion / Bank Caving
Erosion on the slope other small erosion in the area. Fall 2011	
johngw_f_20111108_531.jpg

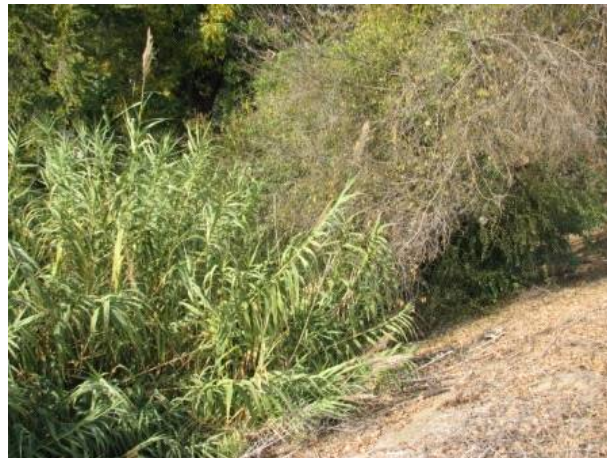
Levee Mile Report Line	12
Start Levee Mile	2.94
End Levee Mile	2.96
Location	Land Side
Category	Earthen Levee
Item	Encroachments
Arundo and vegetation with the landscape.	
johngw_f_20110923_178.jpg

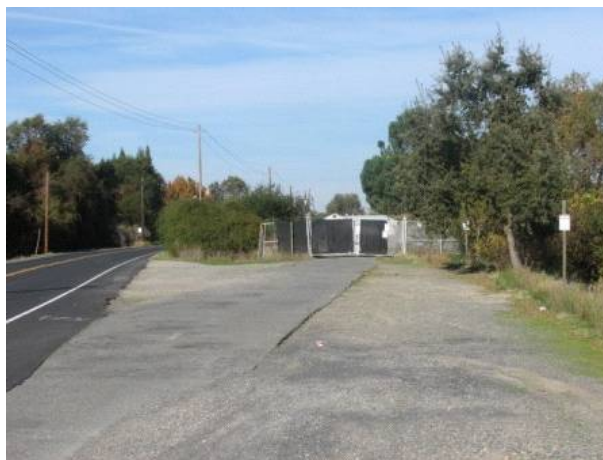
Levee Mile Report Line	13
Start Levee Mile	4.18
End Levee Mile	4.37
Location	Water Side
Category	Earthen Levee
Item	Encroachments

Old Sacramento Weir Yard building and fence compound on levee crown.

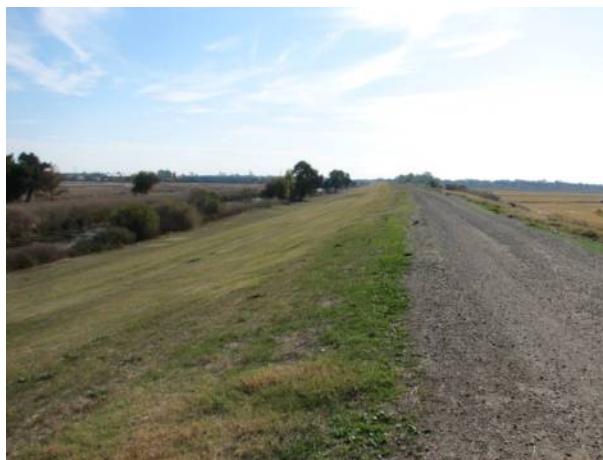
Levee Mile Report Line	1
Start Levee Mile	0.10
End Levee Mile	1.17
Location	Land Side
Category	Earthen Levee
Item	Vegetation

The vegetation meets all standards good grasses and height less then 12 inches. Fall 2011

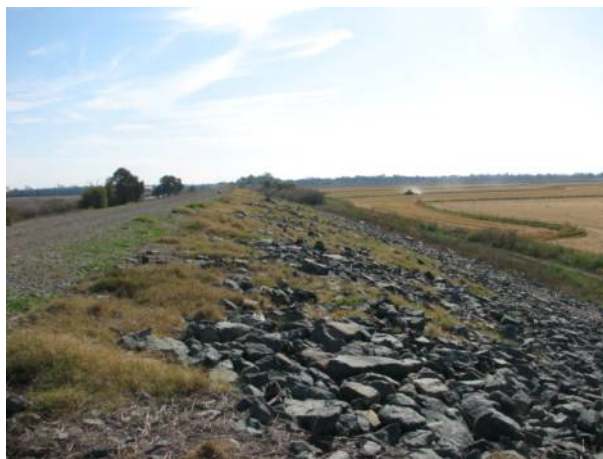
Levee Mile Report Line	2
Start Levee Mile	0.10
End Levee Mile	1.17
Location	Water Side
Category	Earthen Levee
Item	Vegetation

The brush and vegetation meets all standards. Fall 2011
